# **A Summary of Crashworthiness Information of Small Airplanes**

**FEBRUARY 1973**

FAA Technical  
Report No. FS-70-592-120A

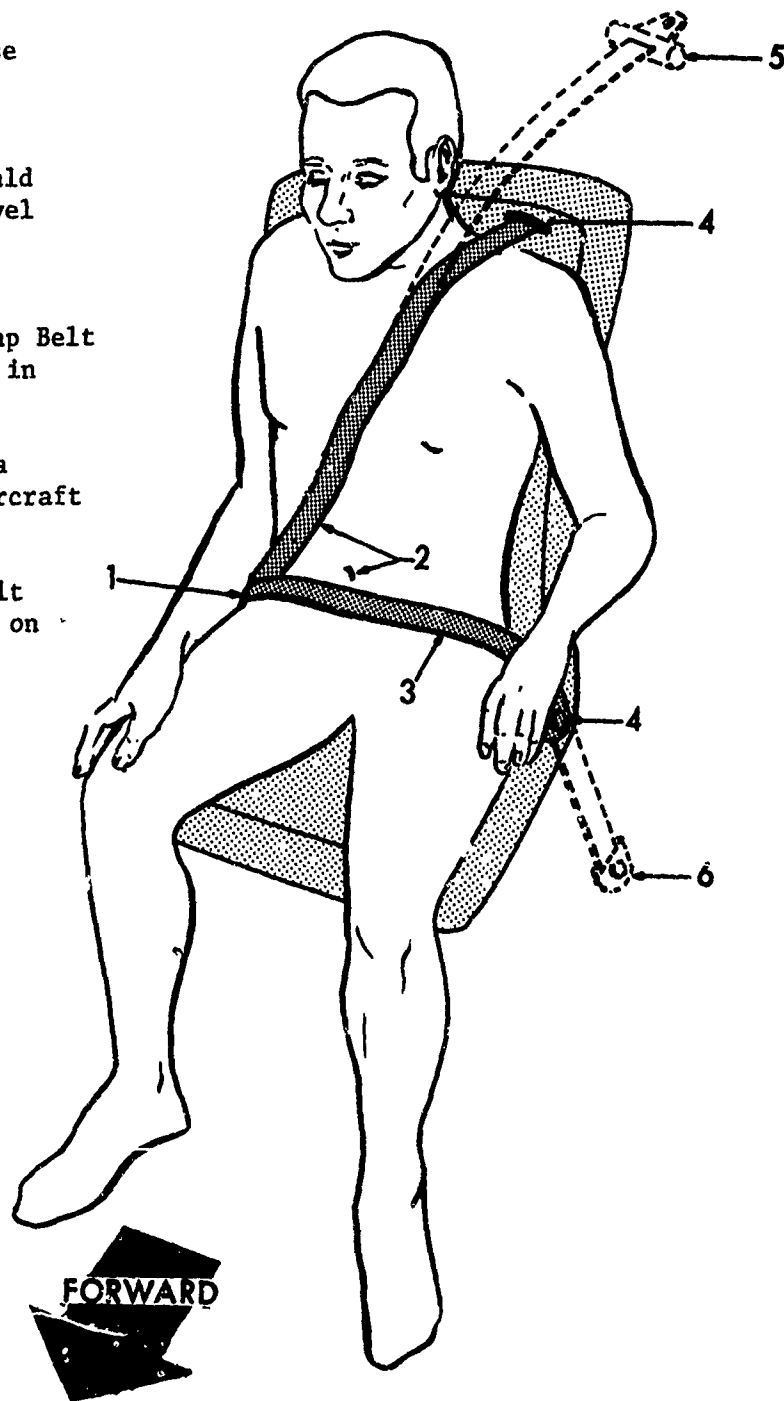
1. Single point release for Lap Belt and Shoulder Strap
2. Shoulder Strap should always be above navel
3. Lap Belt
4. Inertia Reel and Lap Belt attachment located in structural seat.
5. (Alternate) Inertia Ree. located on aircraft structure.
6. (Alternate) Lap Belt attachment located on aircraft structure

Figure 3-15. Single Diagonal Shoulder Strap and Lap Belt System

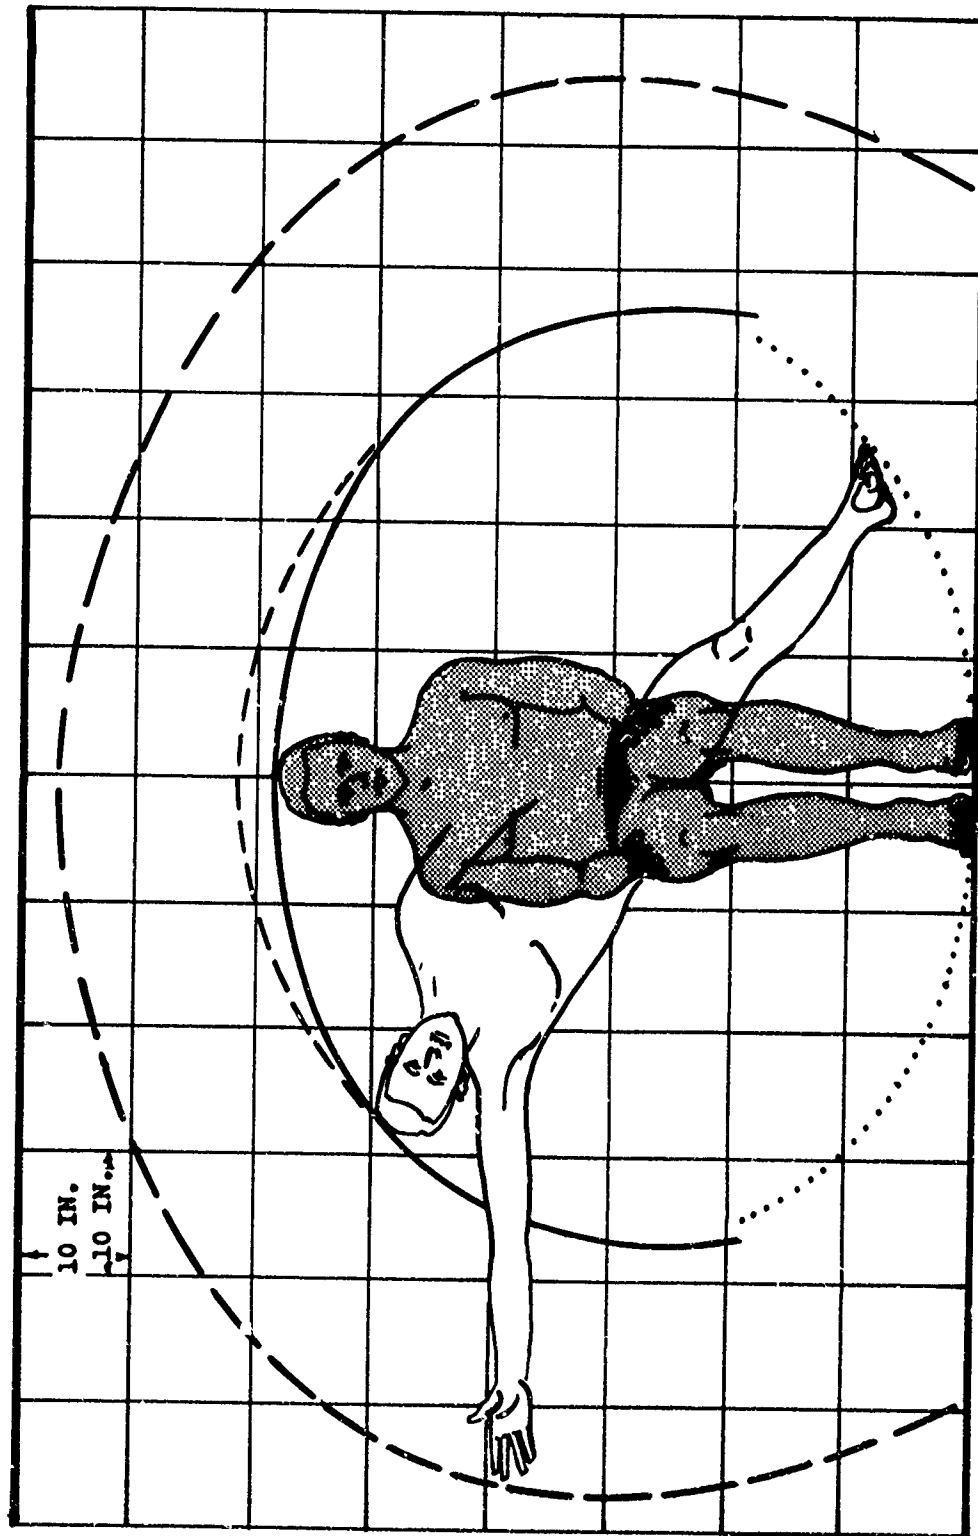
Figure 3-25. Seat-Belt-Only Extremity Strike Envelope - Front View.

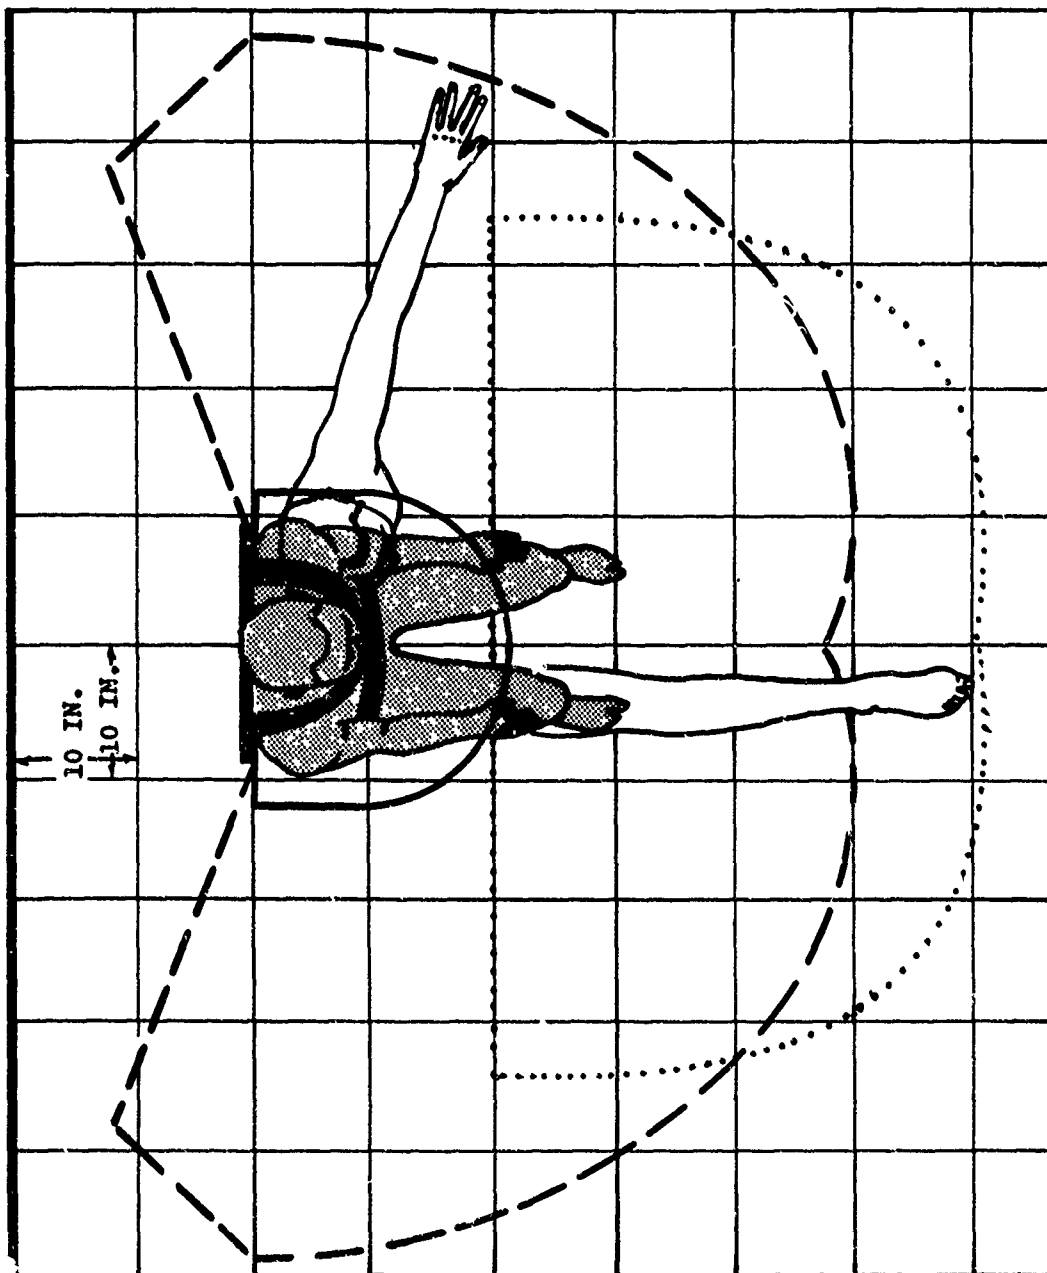
Figure 3-26. Full-Restraint Extremity Strike Envelope - Top View.  
 [Source: USAAVLABS TR 67-22 (5)]

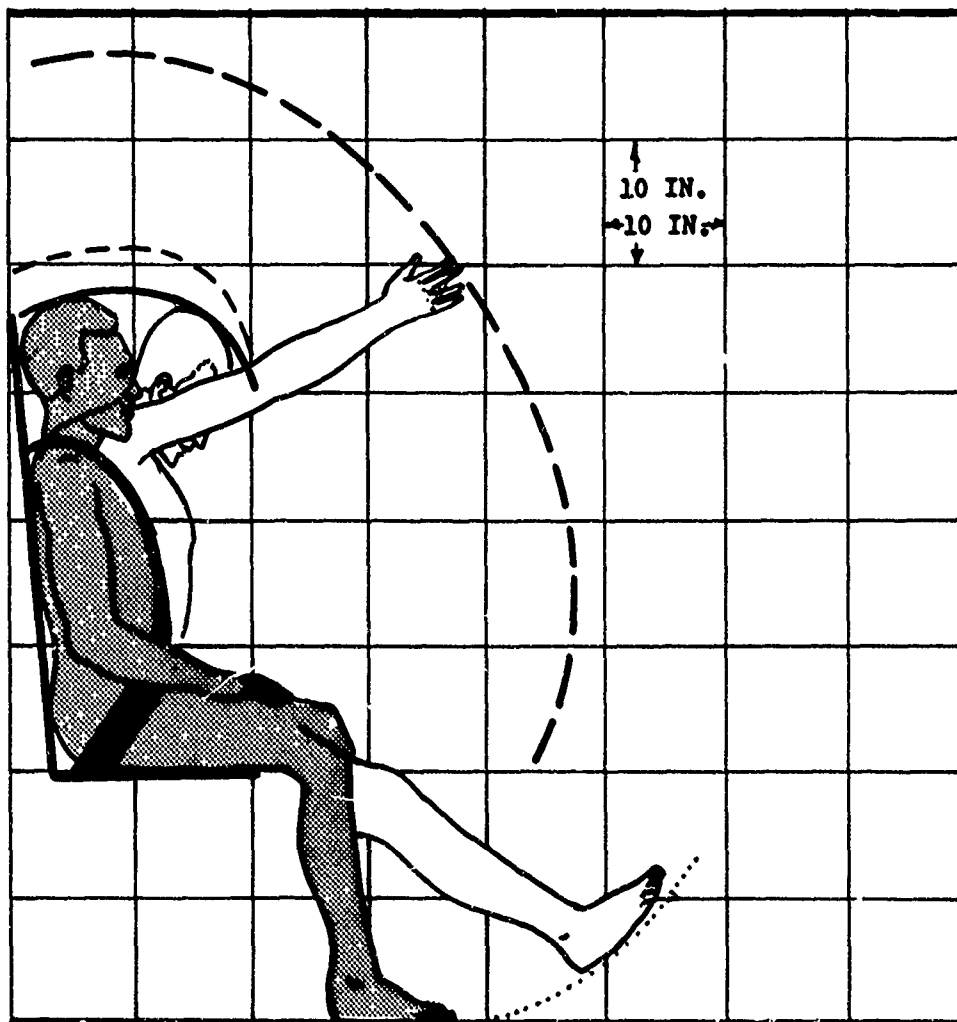
Figure 3-27. Full-Restraint Extremity Strike Envelope - Side View.

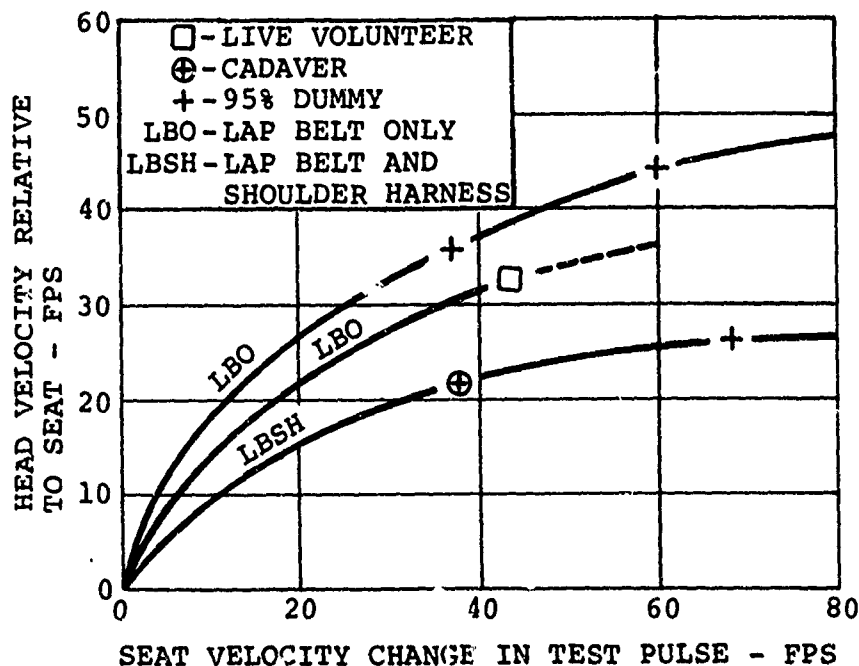
Figure 3-29. Measured Head Velocities in Sled Tests With Anthropomorphic Dummies and Cadavers.

Studies by AvSER and Wayne State University indicate that head impacts at more than 20 fps are not readily tolerated by humans unless the structure has been adequately covered with energy-absorbing material. However, ductile or deforming energy-absorbing structure or construction can be as effective as energy-absorbing padding provided that sharp corners and protrusions are eliminated and the structure/head contact area is large. When the design layout is free of sharp or small radiused corners, edges, and protrusions, attention can be given to design for controlling the magnitudes of the acceleration pulses to which the head may be subjected.

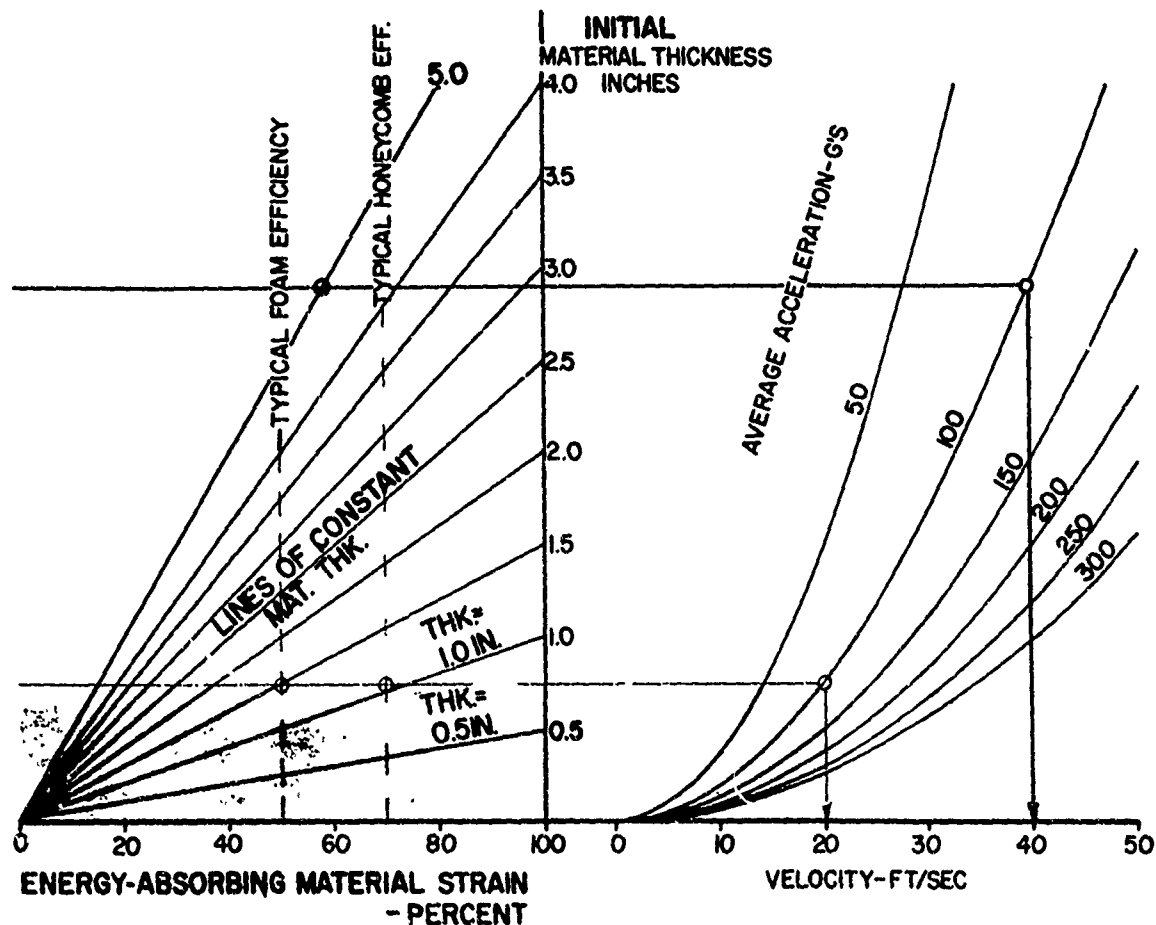
Figure 3-30. Crushable Material Thickness as a Function of Velocity Change and Acceleration Level.

Figure 3-30 shows an approximate correlation between head impact velocity, crushable material thickness (stopping distance), and average acceleration. The material thickness given in this figure is based upon an assumed rectangular acceleration-time pulse and is, therefore, the minimum material thickness suitable under ideal conditions.

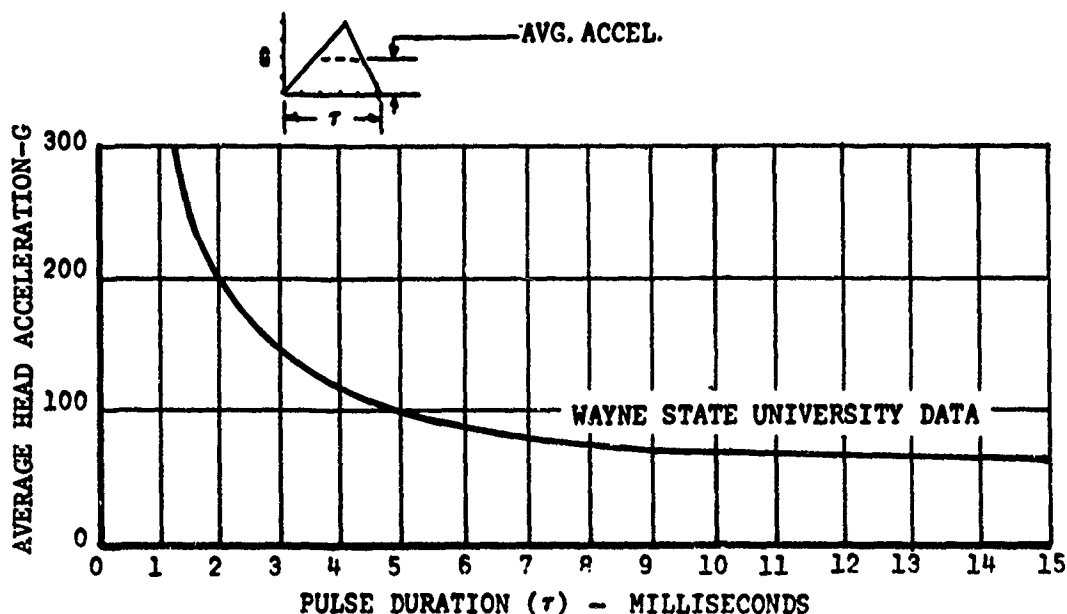
Figure 3-31. Head Tolerance to Impact as a Function of Pulse Duration as Published by Wayne State University.

Figure 3-31 shows an acceleration-time plot of the average acceleration versus the total period of the impulse required to approach unconsciousness limits. This plot was reported by Dr. Gurdjian and others of Wayne State University after extensive experiments with cadavers and live animals in their work on skull fracture and concussion.

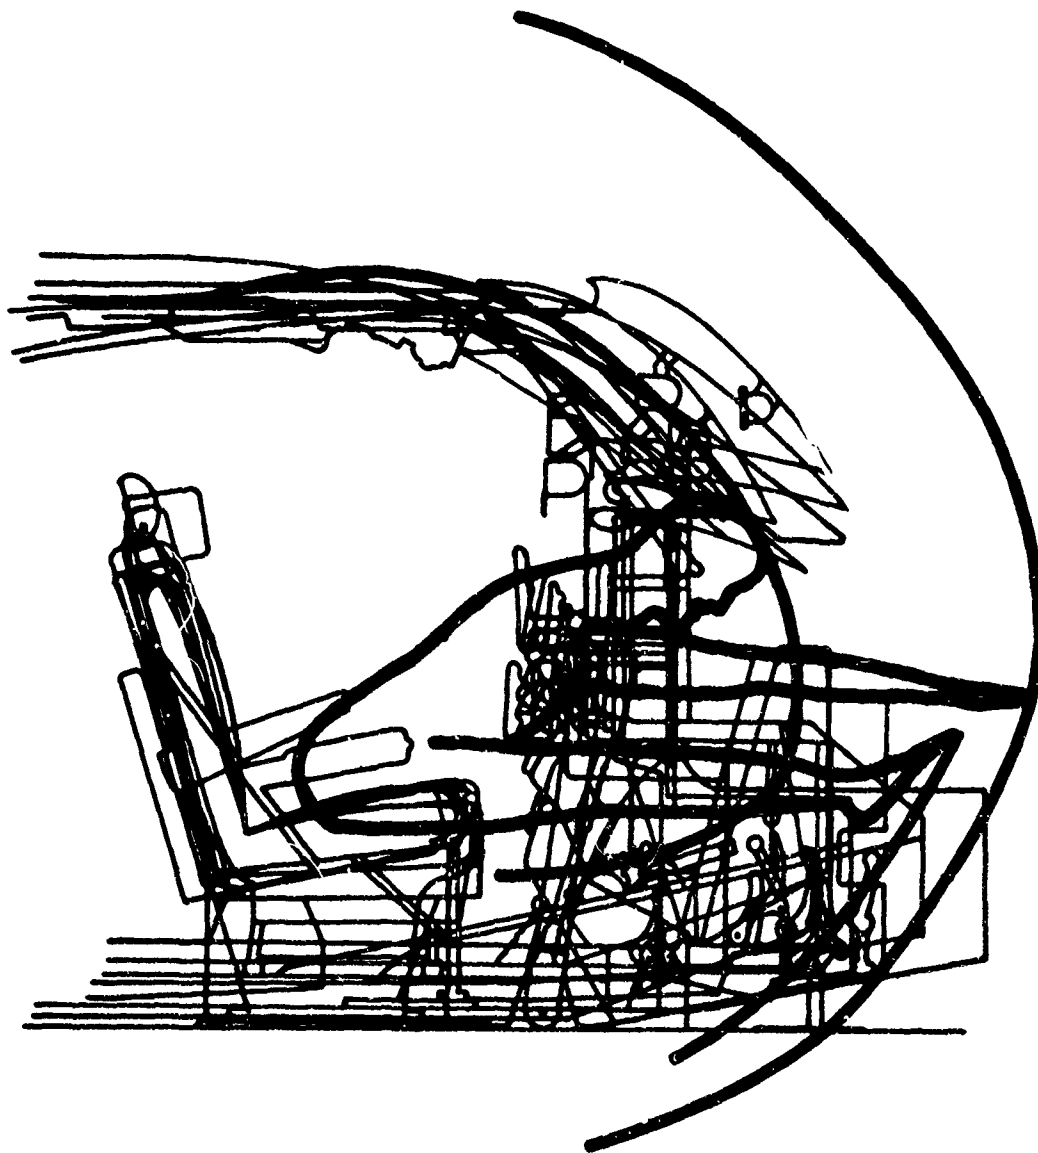
Figure 3-32.

Figure 3-32 shows a 95th percentile male's forward flailing area superimposed on a scale drawing conglomerate of a number of late model light airplanes. Figure 3-32 also shows how a front seat occupant, restrained only by a seat belt, can contact an airplane's interior structure.

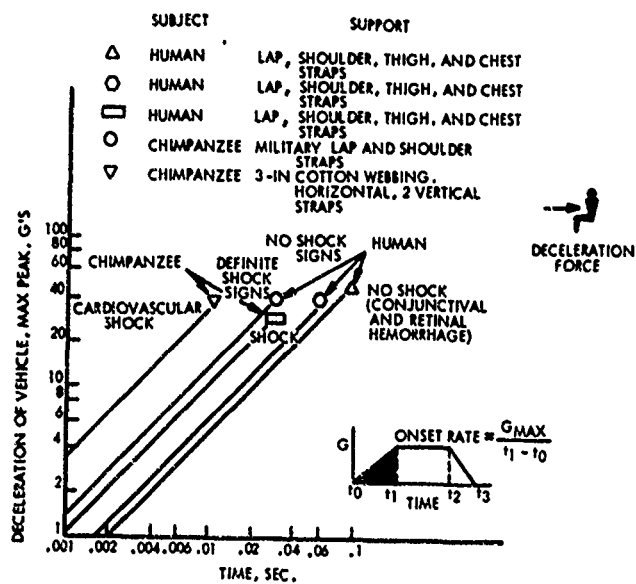
FIGURE A-6B. - EFFECT OF RATE OF ONSET ON SPINEWARD DECELERATION TOLERANCE  
[SOURCE: NASA MEMO 5-19-59E (1)]

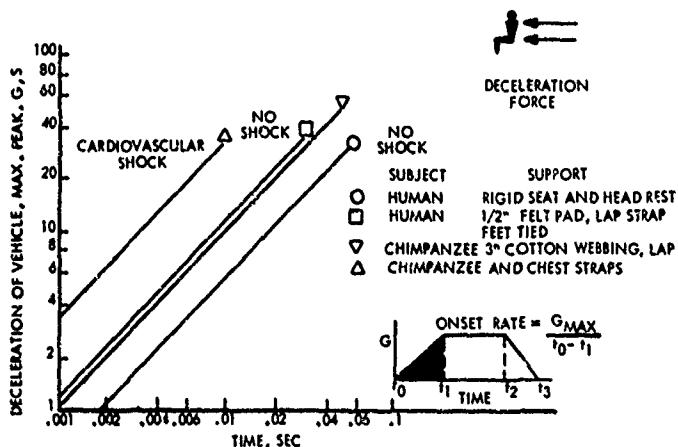
FIGURE A-7B. - EFFECT OF RATE ON ONSET ON SPINEWARD DECELERATION TOLERANCE  
[SOURCE: NASA MEMO 5-19-59E (1)]

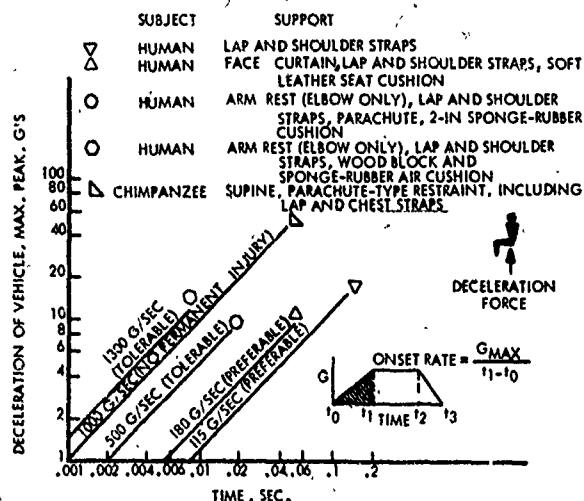
FIGURE A-8B. - EFFECT OF RATE OF ONSET ON HEADWARD DECELERATION TOLERANCE  
[SOURCE: NASA MEMO 5-19-59E (1)]

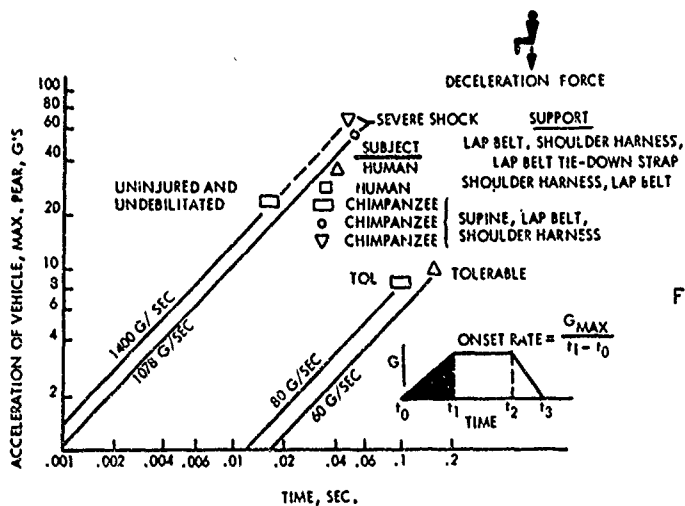
FIGURE A-9B. EFFECT OF RATE OF ONSET ON TAILWARD DECELERATION TOLERANCE  
[SOURCE: NASA MEMO 5-19-59E (1)]
